CONTINUING ELIGIBILITY INSPECTION (CEI) REPORT
FOR HURRICANE & SHORE PROTECTION PROJECTS
Honolulu Engineer District
CEPOH-EC-T

1. Project Name: Asquirola SPP
2. Date of Inspection: February 3, 2005
3. Inspection Personnel:

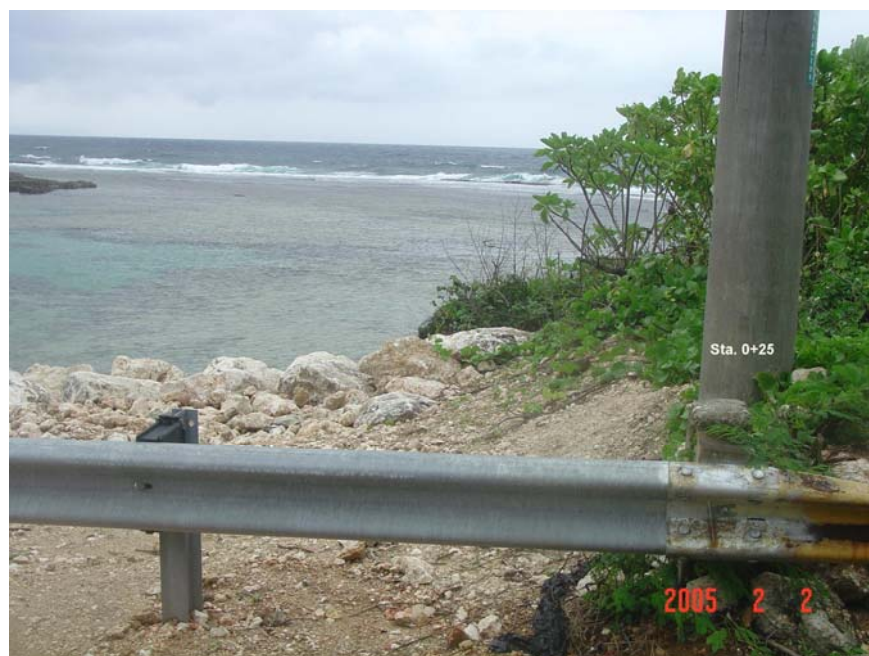
- a. Sta. 0+25, Start of armor stone structure, (South / Talofofoside).

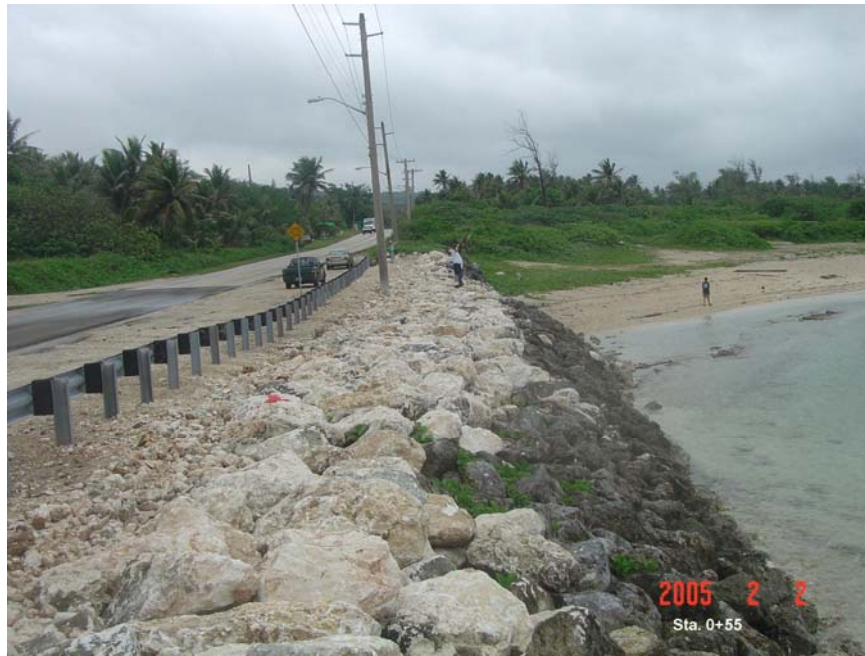
b. Sta. 0+55, Overview

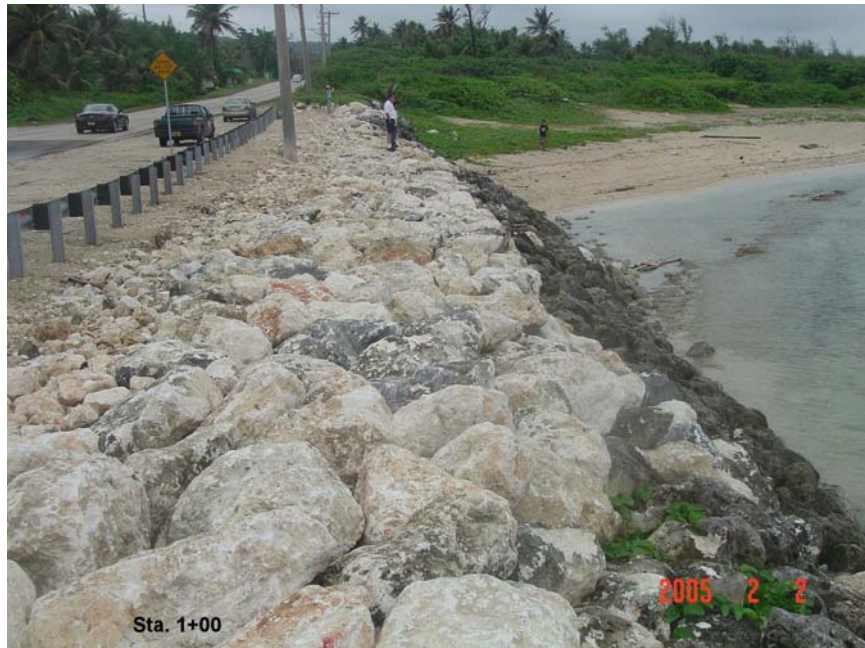
c. Sta. 1+00, Overview of crest and sideslope.

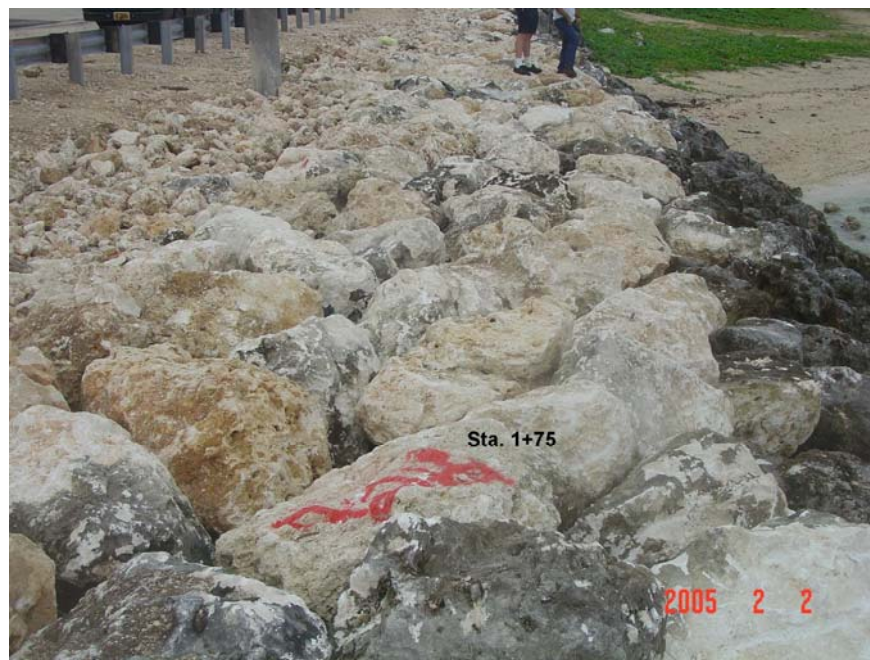
d. Sta. 1+75, (Reference red paint on crest armor stone).

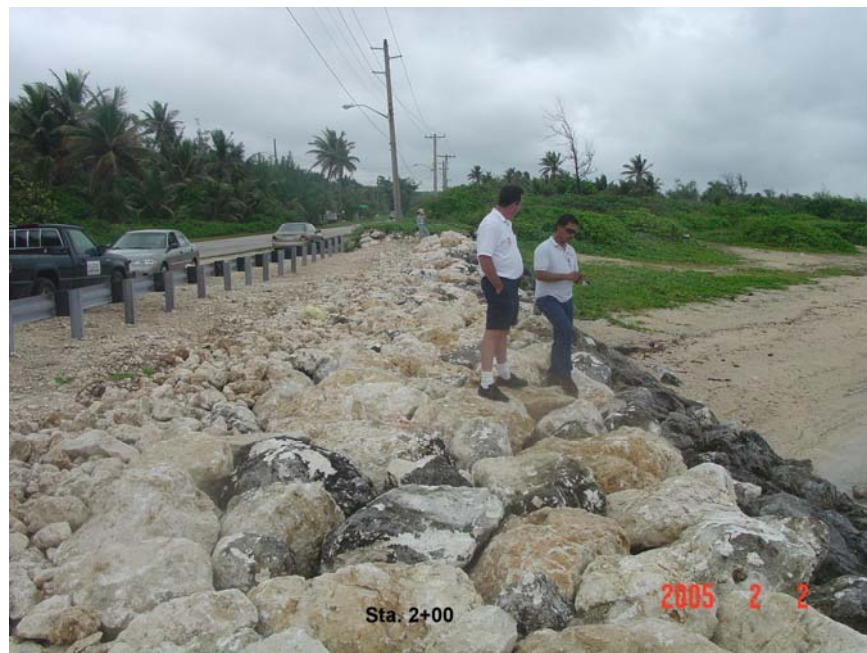
e. Sta. 2+00, Overview

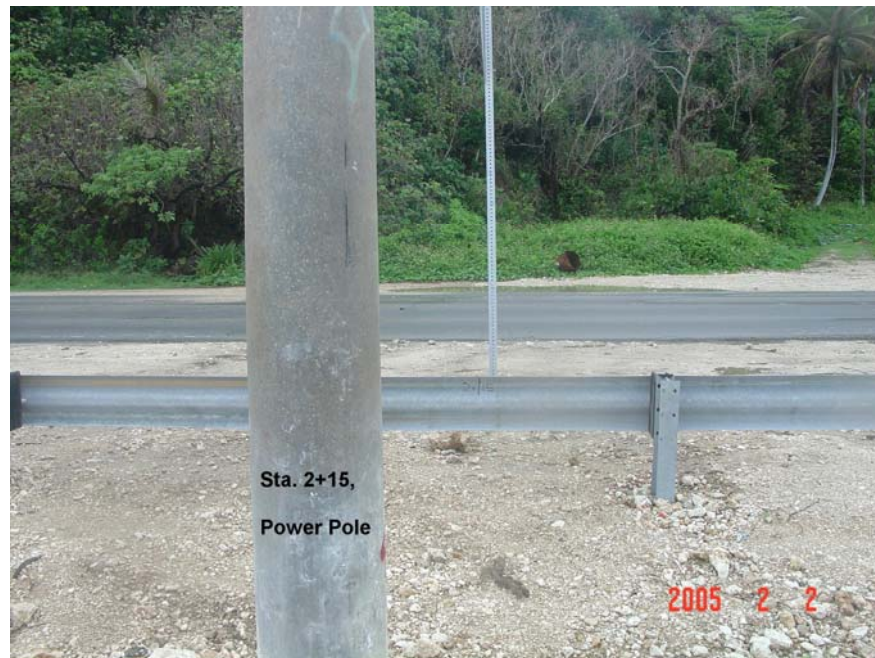
f. Sta. 2+15, Reference power pole.

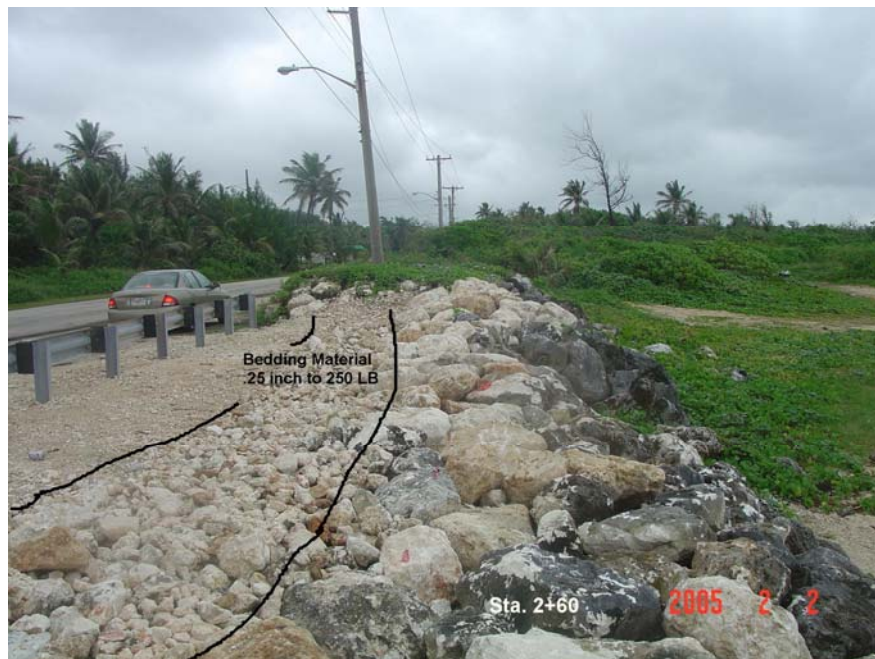
g. Sta. 2+60, note bedding material .25 inch to 250 LB.

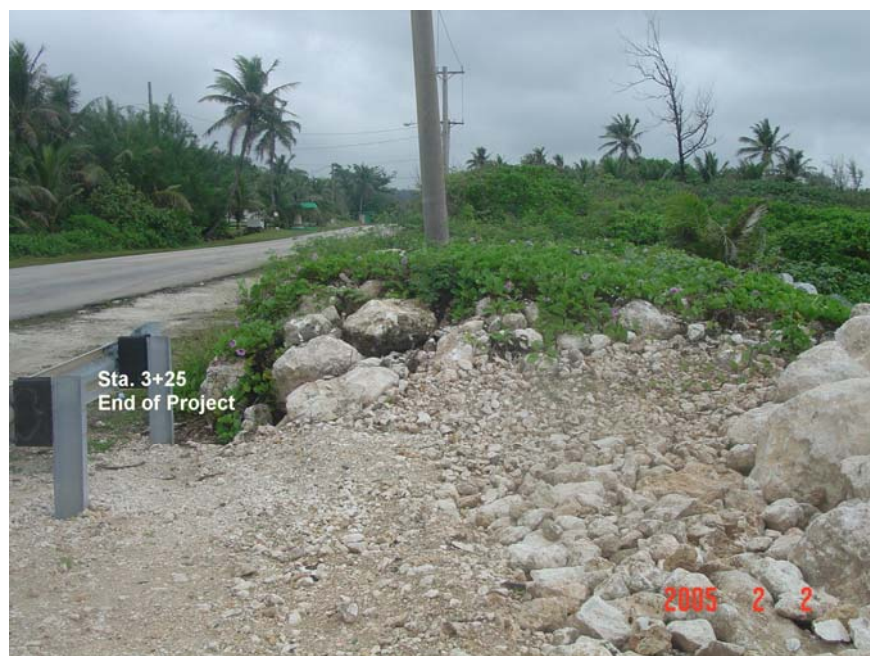
h. Sta. 3+25, End of Federal Project (North-side) there is a transition to the Non-Federal portion of the SPP. The structure beyond Sta. 3+25 is not included in the PL84-99 Program.
